3 Summary of Watershed Conditions

This watershed management plan combines an assessment of three non-contiguous watersheds: Belle Haven, Dogue Creek and the Fairfax County portion of the Four Mile Run watershed, into one document. These watersheds are located in southeastern and eastern Fairfax County as shown on Figure 3-1. The Dogue Creek watershed was divided into five Watershed Management Areas (WMAs). Due to their smaller size, the Belle Haven and Four Mile Run watersheds were not divided into WMAs and thus the entire watershed for each was treated as a single WMA. Watershed Management Area and subwatershed boundaries for these three watersheds are shown on Figures 3-3, 3-6 and 3-9. A summary of each watershed is discussed separately in the sections that follow. Detailed information regarding watershed conditions can be found in the Draft Belle Haven, Dogue Creek and Four Mile Run Watershed Workbook, dated January 2009, located in Appendix A.

3.1 Belle Haven Watershed

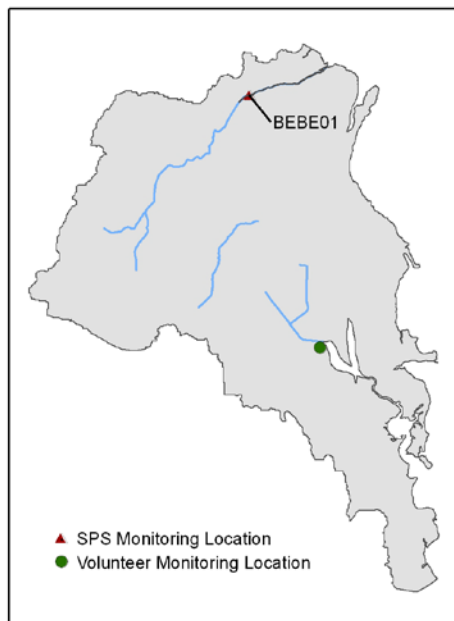
Figure 3-2: SPS baseline and volunteer sampling sites – Belle Haven watershed

There was one site sampled during the SPS Baseline Study. The site, BEBE01, is located on Hunting Creek, as shown on Figure 3-2, and the results are listed in Table 3-1. The composite condition rating for this site was very poor. This site received some of the lowest scores of the entire coastal plain system in Fairfax County. The high level of impervious area and the limited stormwater controls implemented when this watershed was initially developed are likely contributing to poor habitat quality. The most significant problem noted in the SPS Study was the limiting of habitat quality by sediment deposition.

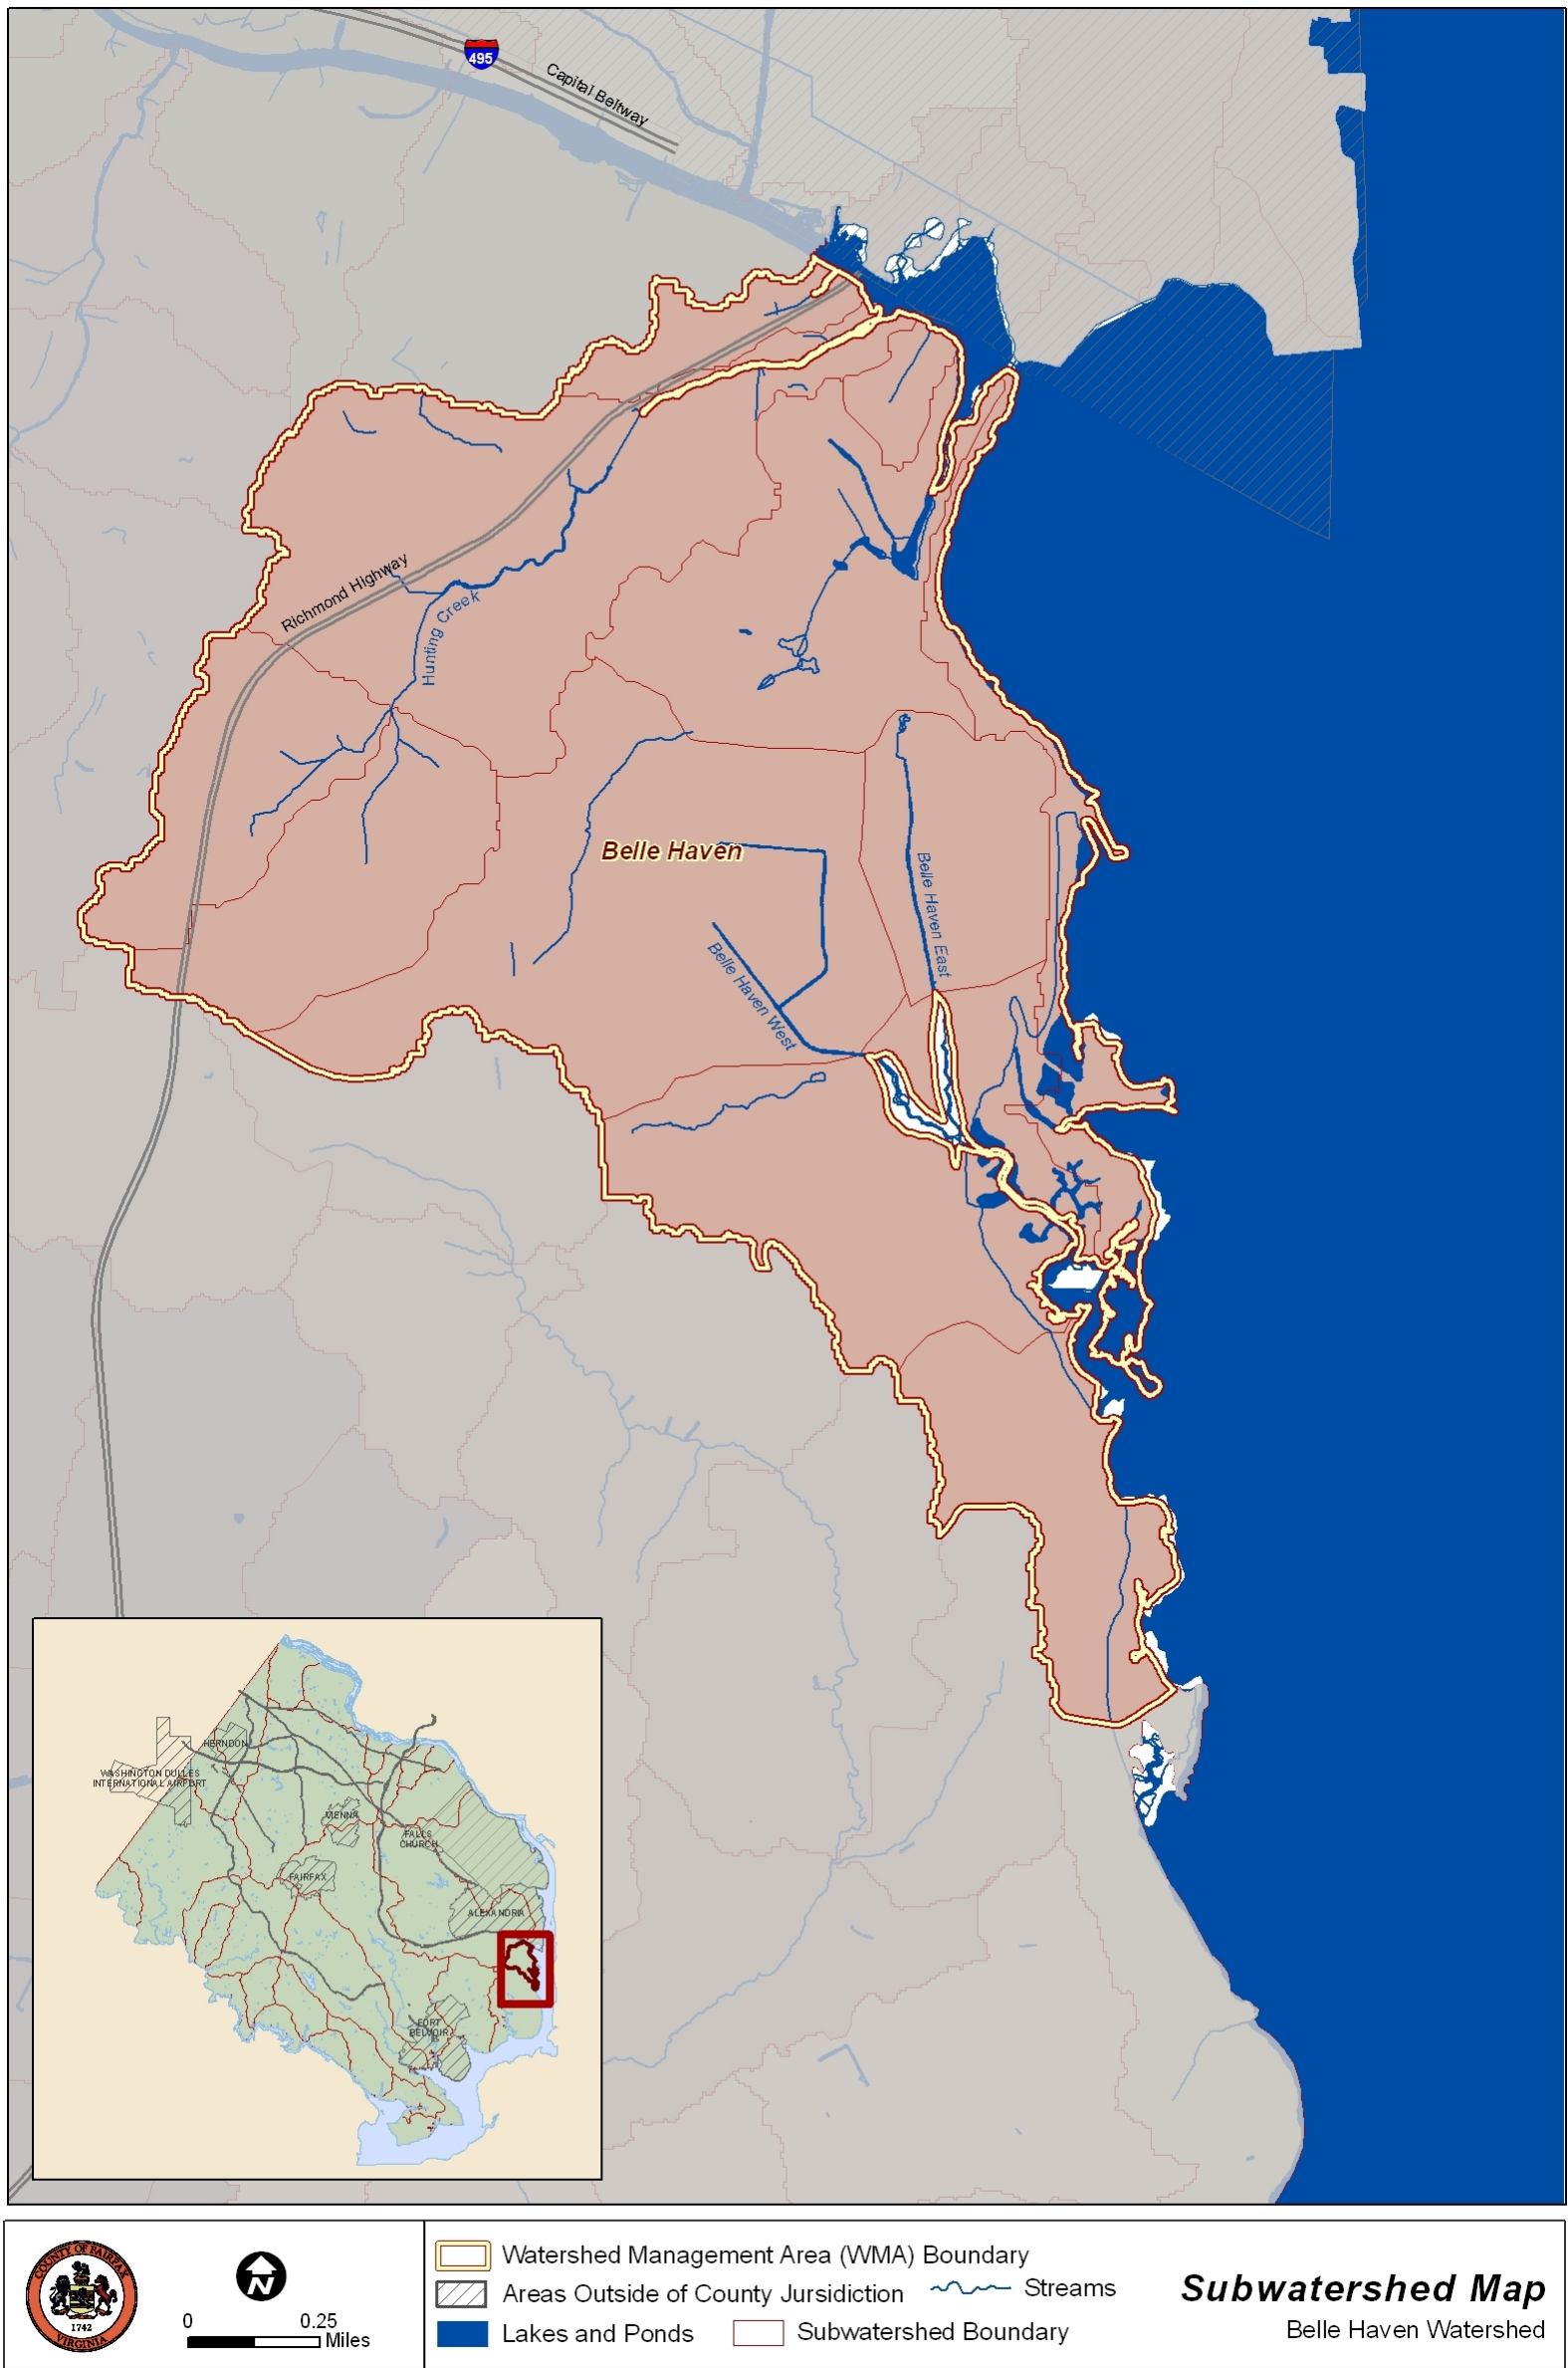
Figure 3-3: Belle Haven Watershed Map

The Belle Haven watershed is approximately 2.7 square miles and is part of the Potomac River Basin. As shown in Figure 3-3, the main waterway within the watershed is Hunting Creek (known locally as Quander Brook), which flows for nearly two miles in a northeastern direction from its headwaters near the junction of the Richmond Highway and Beacon Hill Road to its confluence with Cameron Run just upstream of the mouth of Cameron Run where it flows into the Potomac River near the Woodrow Wilson Bridge. The two other principal waterways in the watershed are direct tributaries to the Potomac River, one flowing northeast parallel to and east of Hunting Creek and draining to tidewater, and the other, known as Belle Haven, consisting of three branches flowing southeast to the Potomac River. There are 166 acres of wetlands, the majority of which are freshwater emergent or forested/shrub wetlands.

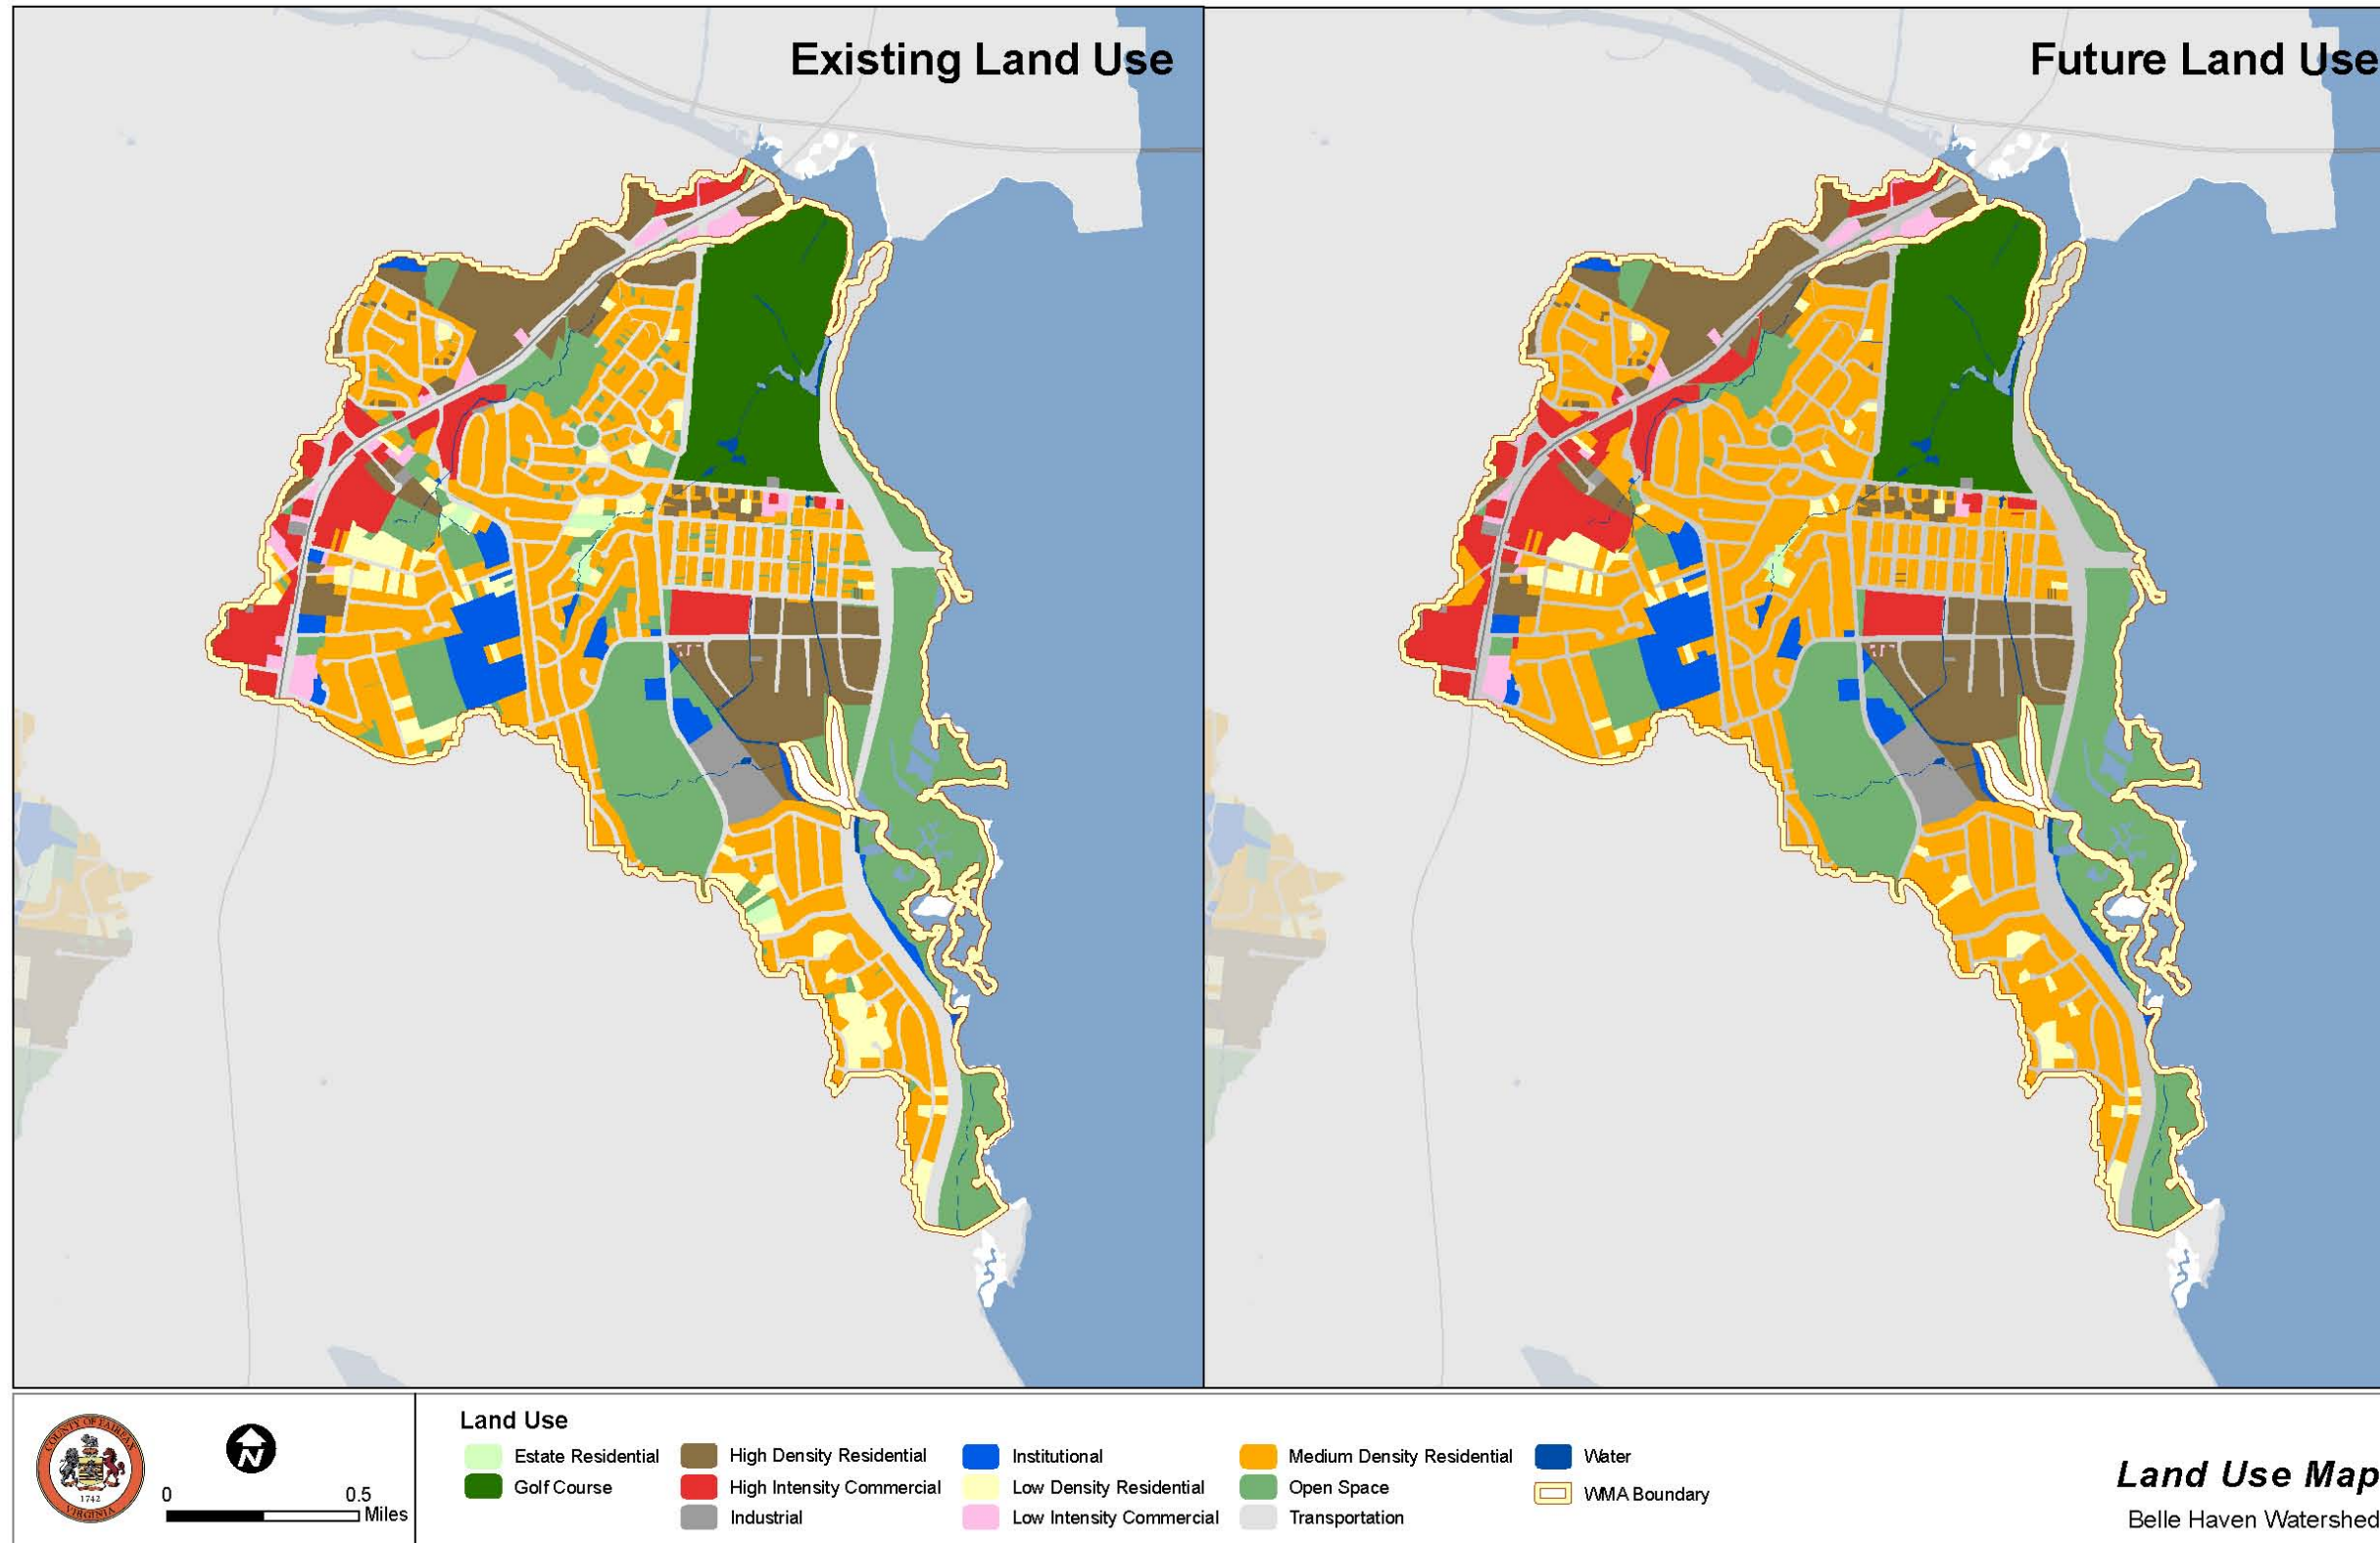
Figure 3-4: Belle Haven Land Use Map

Approximately 69 percent of the watershed is developed with the majority, 41 percent, in various residential land uses. Current and future land uses are shown on Figure 3-4, Belle Haven Land Use Map. Commercial areas are primarily located along North Kings Highway and Richmond Highway in the northwestern portion of the watershed. Existing imperviousness is 32 percent and is expected to increase by approximately 1.5 percent from future development. Several environmental problems have been accelerated by development, including increased stream erosion and stream sedimentation due to concentrated points of stormwater runoff.

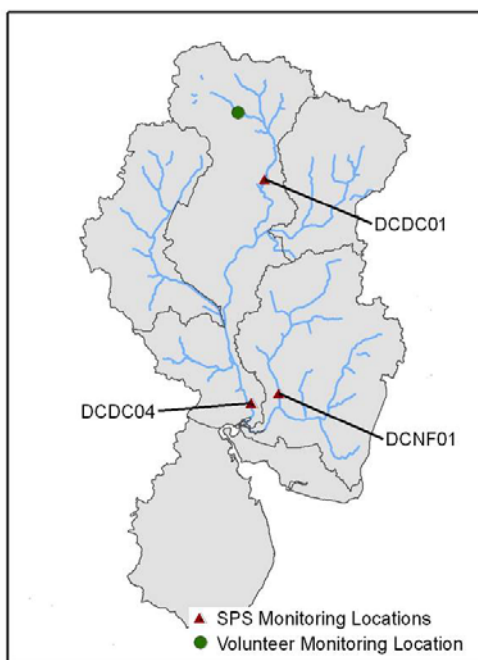
Figure 3-5: SPS baseline and volunteer sampling sites - Dogue Creek watershed

The results of the data collected from the three SPS baseline study sampling sites within the Dogue Creek watershed are shown in Table 3-4 (listed generally upstream to downstream). SPS monitoring locations are shown on Figure 3-5. Composite condition ratings for sites in the watershed ranged from poor (in the North Fork WMA at site DCNF01) to good at the two Dogue Mainstem WMA sites. Habitat was fair at all three sites, but sampling of biological health varied from good at the upstream Dogue Mainstem site, DCDC01 (where fish taxa richness was also high) to very poor at the North Fork site. Goldfish, an exotic species, were noted throughout the Dogue Creek stream system, with naturalized populations present in

There is one NVSWCD monitoring site in the Dogue Creek watershed, as shown in Figure 3-5. This site is located on a tributary to the mainstem of Dogue Creek near its headwaters and received a rating of unacceptable. A separate volunteer monitoring program conducted within Huntley Meadows Park indicates good habitat with only a few problem areas.

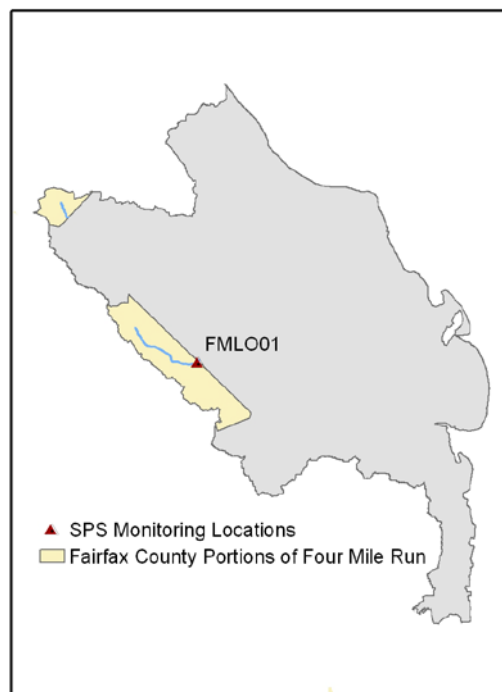
Figure 3-8: SPS baseline and volunteer sampling sites - Four Mile Run watershed

There was one site sampled during the SPS Baseline Study. The site, FMLO01, is located on Upper Long Branch, as shown on Figure 3-8, and the results are listed in Table 3-7. The composite condition rating for the sampling site was very poor. Habitat was very poor and fish taxa richness was very low with the sample dominated by tolerant species. The index of biotic integrity was poor. Stream modification was noted as a

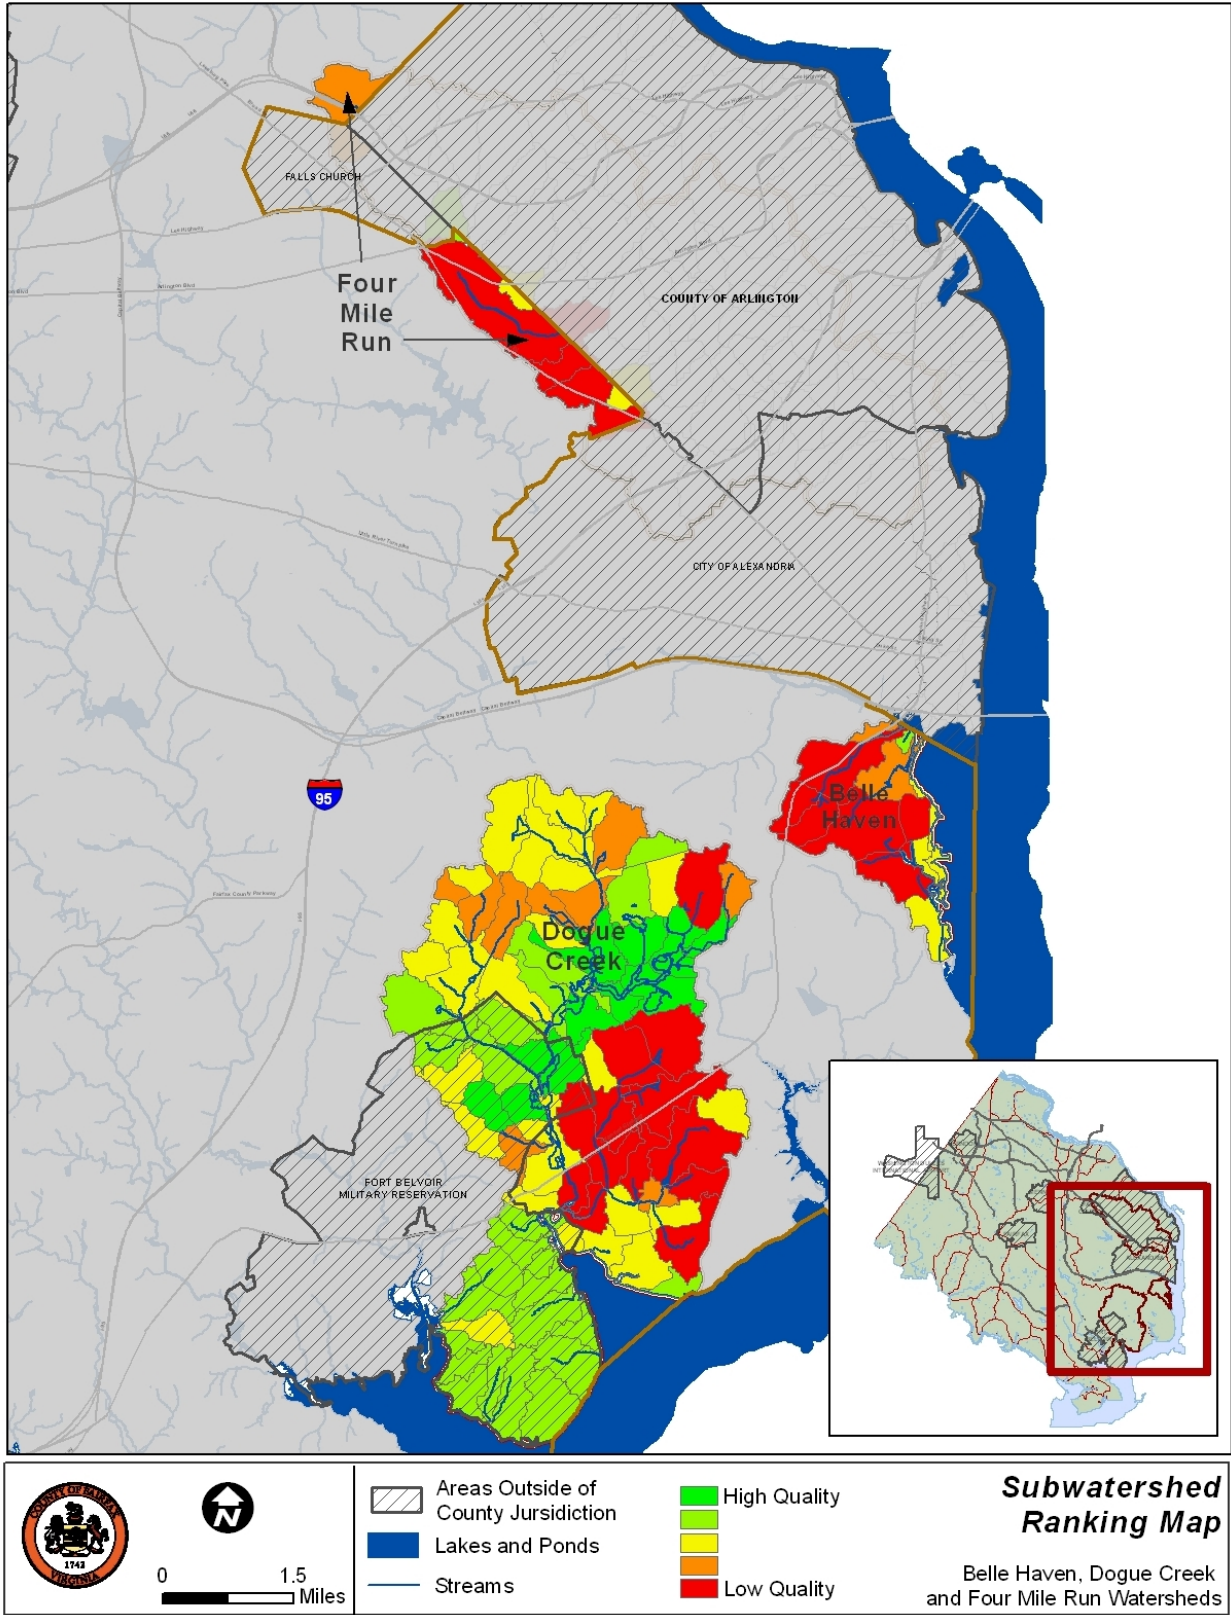
Figure 3-11: Subwatershed Ranking Map

The subwatershed ranking procedure described in Section 2.3 was performed on all three watersheds as if they were a single entity. A short description of the subwatershed scores for each of the watersheds is provided in the separate watershed discussions above. Figure 3-11 shows the results of the ranking through color gradation between green (best) to red (worst). Of the three watersheds, Belle Haven's subwatersheds scored the lowest, with an average score of 4.37 out of 10.0. The Four Mile Run subwatersheds ranked slightly better than those in Belle Haven, with an average score of 4.42. Dogue Creek had the highest quality subwatersheds and overall best average score of 5.51. The results of the subwatershed ranking were an integral part of identifying the highest priority projects for restoring the watershed and stream systems.
