Appendix H: Stream Restoration Projects

Clifton Creek #2 Stream Restoration Project

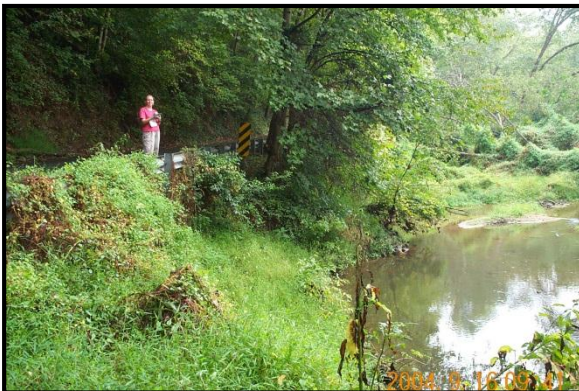
Stream adjacent to Clifton Creek Drive

Stream Width:	15'
Stream Restoration Possibilities:	Stabilization bank or minor channel realignment to reduce erosion of bank adjacent to Clifton Creek Drive and prevent road failure. No existing stabilization measures were visible along road edge.
Cost:	Total Cost \$120,000.

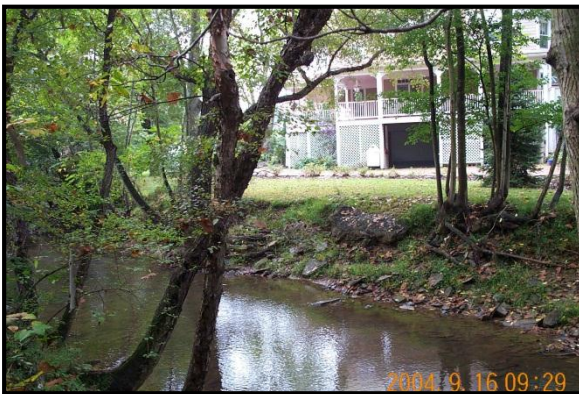
Private landowner side with no buffer

Stream Width: 15'
 Stream Restoration Possibilities: Spot Stabilization of approximately 50% of stream along Clifton Creek Drive side and private landowner side. One location where stream is adjacent to Clifton Creek Drive and further road failure is possible. Three – five locations on private landowner side where bank stabilization is necessary to reduce future property loss. Increase buffer on private landowner side along entire reach length.
 Cost: Total Cost \$90,000. (based on stabilization of 50% of stream length)

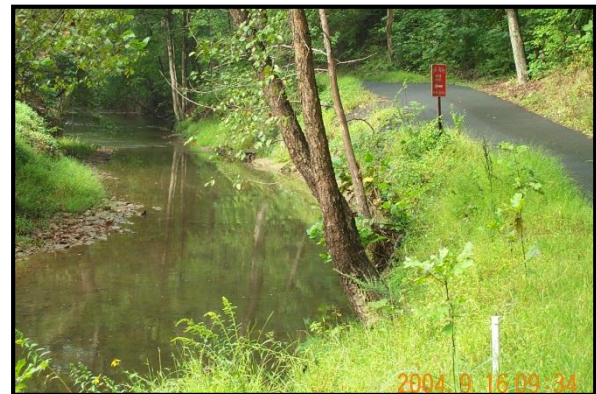
Stream adjacent to Clifton Creek Drive

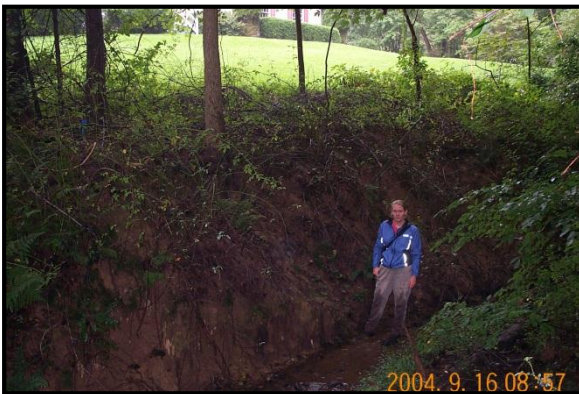
Eroded bank adjacent to Clifton Road.

Stream Width: 2-4'
 Stream Restoration Possibilities: Spot Stabilization of stream as necessary. Several locations where erosion of Clifton Road is possible. Several locations where outfalls to the stream channel are highly eroded. Several locations where the buffer needed to be increased and stream stabilized adjacent to houses.
 Cost: Total Cost \$360,000. (based on stabilization of 35% of stream length)

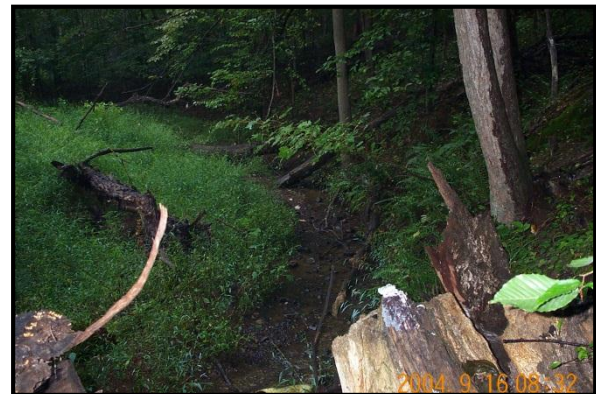
Stable stream section along Clifton Road.

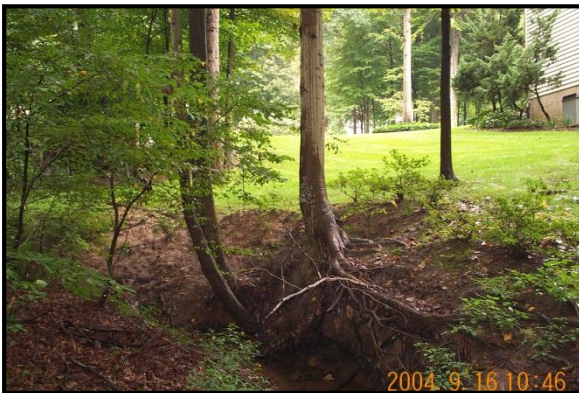
Eroded bank near Young Branch.

Stream Width: 2-4' adjacent to Young Branch, 4-6' near Havenner Road
 Stream Restoration Possibilities: Stabilize 2-4' tall banks along 85% of reach adjacent to Young Branch. Several areas where landowner mowed to stream edge need buffer restoration. Several locations with 20-40' tall eroded banks adjacent to private homes need stabilization or minor channel realignment near Havenner Road.
 Cost: Total Cost \$1,080,000.

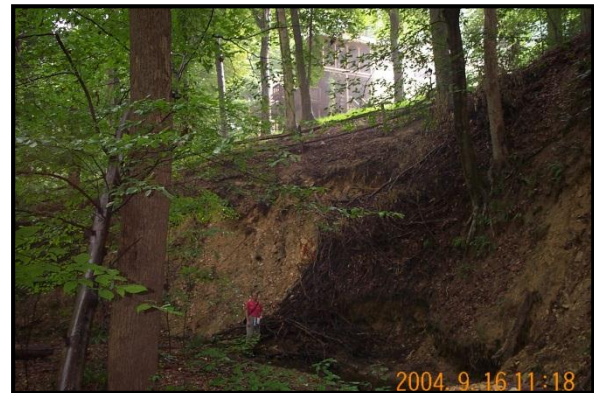
40' eroded bank near Havenner Road.

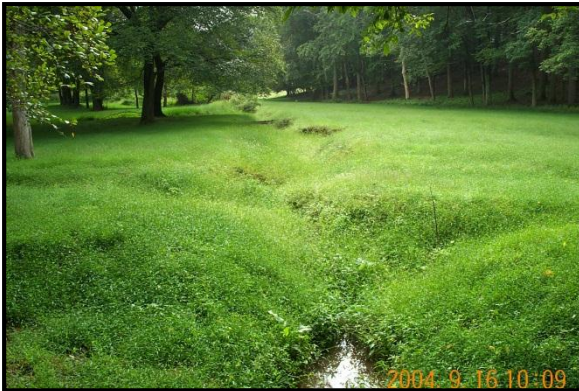
Stream downstream of Wycklow Drive.

Stream Width: 1-2'
 Stream Buffer Restoration Possibilities: Increase buffer along entire stream length to reduce future erosion and decrease pollutants to stream. Small stream with minor erosion that would be minimized with adequate (20-50') buffer. Stream flows through private land, therefore buffer width will be dependent on landowner participation.
 Cost: Total Cost \$60,000.

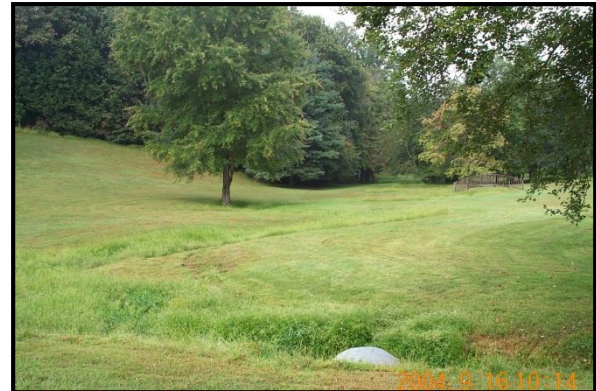
Stream upstream of Wandering Lane.

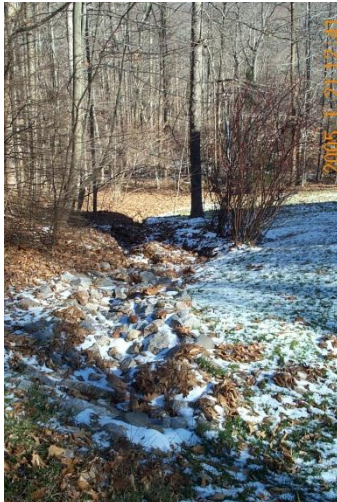
Stream just downstream of Queens Brigade Drive.

Stream Width: 1-2'
Ditch Stabilization Possibilities: Ditch is eroded. Investigate local drainage pattern and armor ditch to prevent further erosion.
Cost: Total Cost \$20,000.

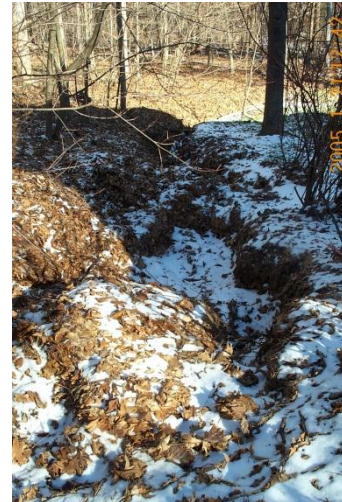
Stream approx 50 feet downstream of Queens Brigade Drive.

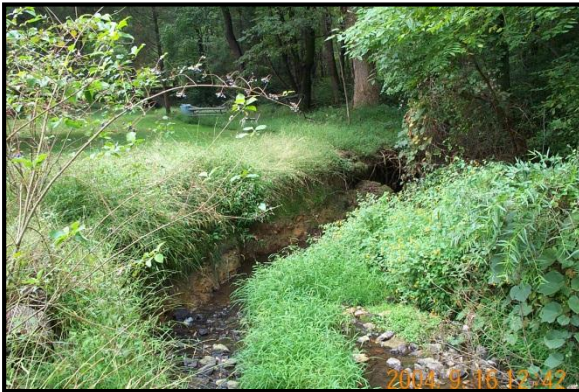
3' eroded bank with no buffer.

Stream Width: 3-6'.
 Stream Restoration Possibilities: Stream flows out and back into the County Club of Fairfax through private land. Increase the stream buffer as able with landowner participation. Stream has some erosion, but minor and not threatening any structures.
 Cost: Total Cost \$30,000.

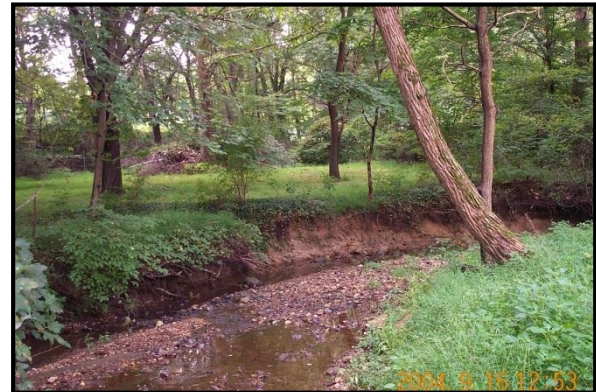
3-4' eroded bank with no buffer.

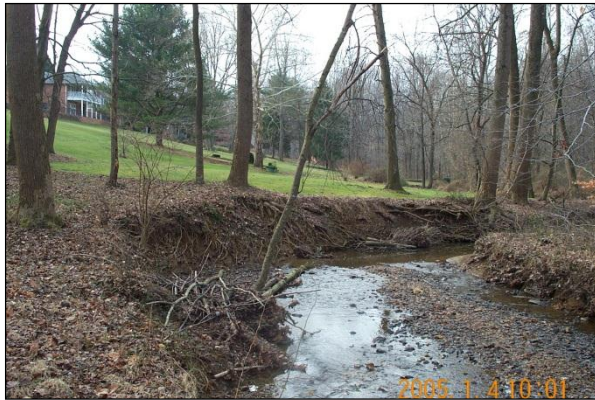
Eroded bank adjacent to mowed lawn.

Stream Width:	8-12'
Stream Restoration Possibilities:	Stabilize 2-4' tall banks along 75% of the reach. The landowners have mowed the lawn to the eastern stream banks, therefore buffer restoration is needed to prevent future land loss. Remove large wood debris obstruction from blocking the channel at the south end of the reach.
Cost:	\$330,000.

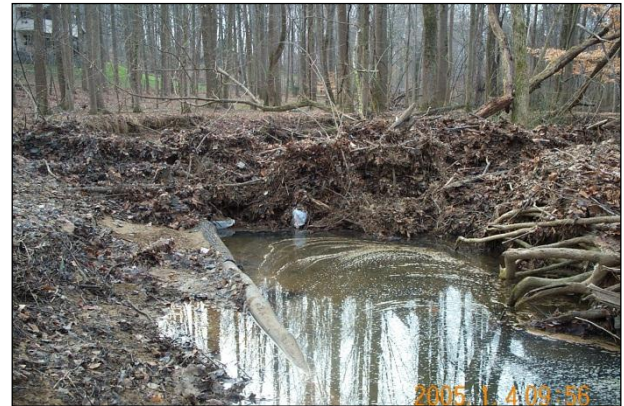
Large obstruction.

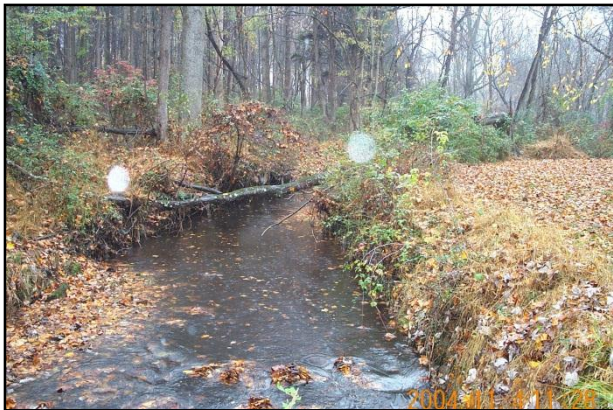
Eroded bank adjacent to mowed lawn.

Stream Width:	8-12'
Stream Restoration Possibilities:	Stabilize 2-4' tall banks along 75% of the reach. The landowners have mowed the lawn to the eastern stream banks, therefore buffer restoration is needed to prevent future land loss.
Cost:	\$310,000.

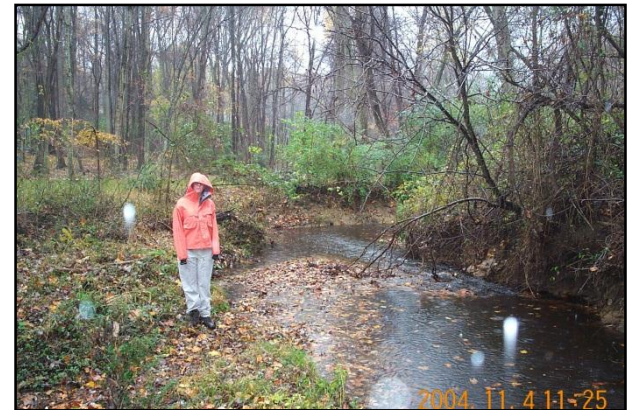
Stream erosion along outside bend.
