# **Belle Haven, Dogue Creek and Four Mile Run Watershed Management Plan DRAFT**

**Watershed Workbook  
June 2010**

*Fairfax County Department of  
Public Works and  
Environmental Services*

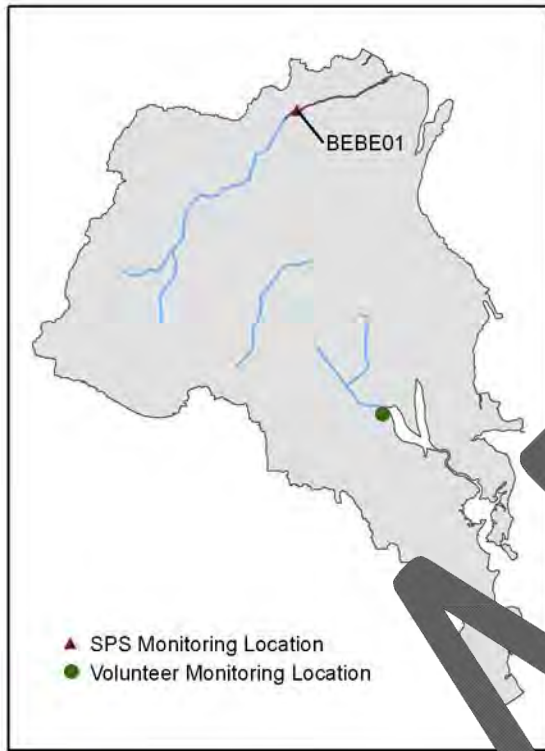
Figure 1-2 – SPS baseline and volunteer sampling sites – Belle Haven watershed.

The results of the data collected from the one sampling site within the Belle Haven watershed for the SPS Baseline Study are shown in Table 1-15. The location of the site, located on Hunting Creek, is shown on Figure 1-2. The composite condition rating for this site was very poor. This site received some of the lowest scores of the entire coastal plain system in Fairfax County. The high level of impervious area and the limited stormwater controls implemented when this watershed was initially developed are likely contributing to poor habitat quality. The most significant problem noted in the SPS Study was the limiting of habitat quality by sediment deposition.
