## 5.0 Watershed Management Area Restoration Strategies

The Lower Occoquan includes eight of the 30 watersheds located within Fairfax County. These eight watersheds drain into the Occoquan River. For planning and management purposes, the County has defined drainage units called watershed management areas (WMAs), which are typically a few square miles of land area. For most of the small watersheds in Lower Occoquan, the entire watersheds are defined as WMAs. The larger Mill branch watershed has been divided into 3 individual WMAs. Figure 5-1 identifies the 10 WMAs within Lower Occoquan, their drainage area size and the number of proposed structural and non-structural projects. Summaries of Lower Occoquan’s 10 WMAs are listed in the following WMA sections including field reconnaissance findings, existing and future land use, stream conditions, and stormwater infrastructure. Each WMA was examined at the subwatershed level in order to capture as much data as possible. The subwatershed conditions were reviewed and problems areas were highlighted. Projects were proposed in problematic subwatersheds. The Lower Occoquan Draft Watershed Workbook, which includes the full watershed character

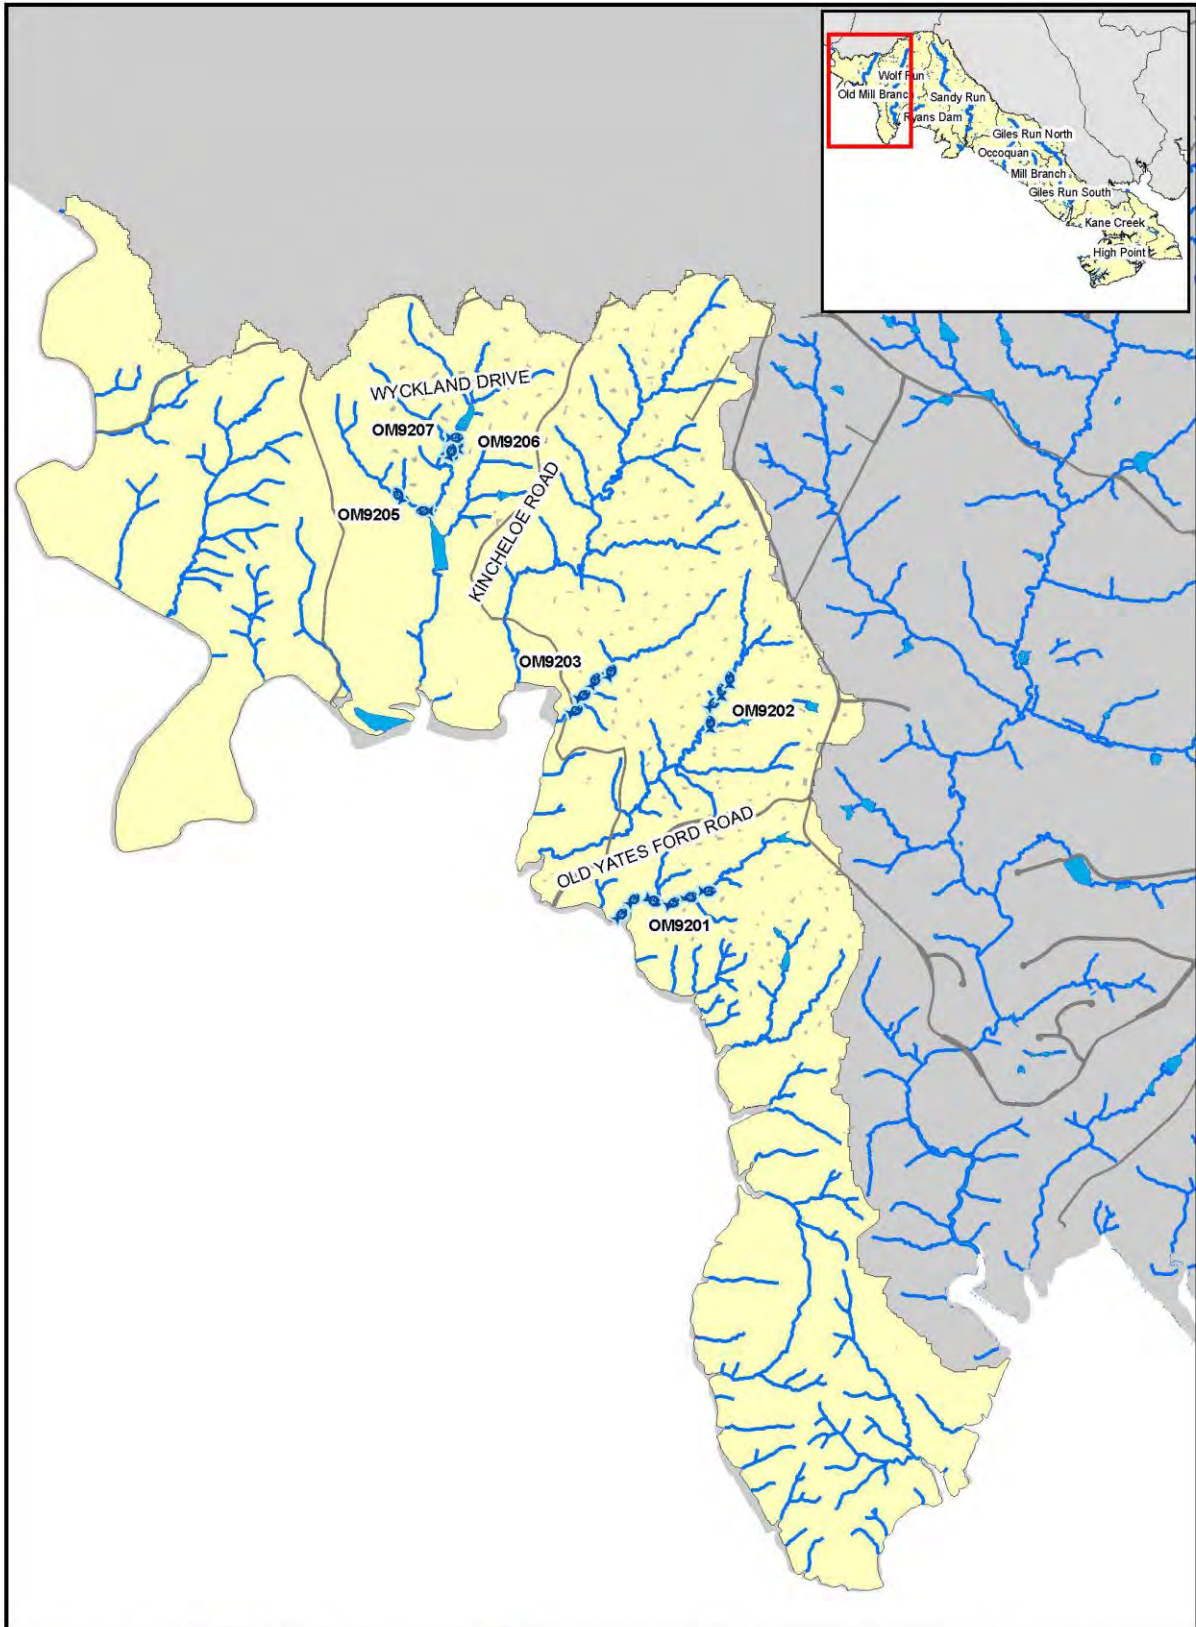
## Map 5.7

Buffer Restoration   Stream Restoration   BMP/LID   Culvert Retrofit   Dumpsite/Obstruction Removal	  New Stormwater Pond   Outfall Improvement   Stormwater Pond Retrofit   Other	  Area-wide Drainage Improvement   Community Outreach/Public Education   Land Conservation Project   Flood Protection/Mitigation   Inspection/Enforcement Enhancement   Rain Barrel Program   Street Sweeping Program  Studies, Surveys and Assessments
	<p>Implementation timeframe denoted by project label color. Red = 0-10 years Black = 11-25 years.</p>

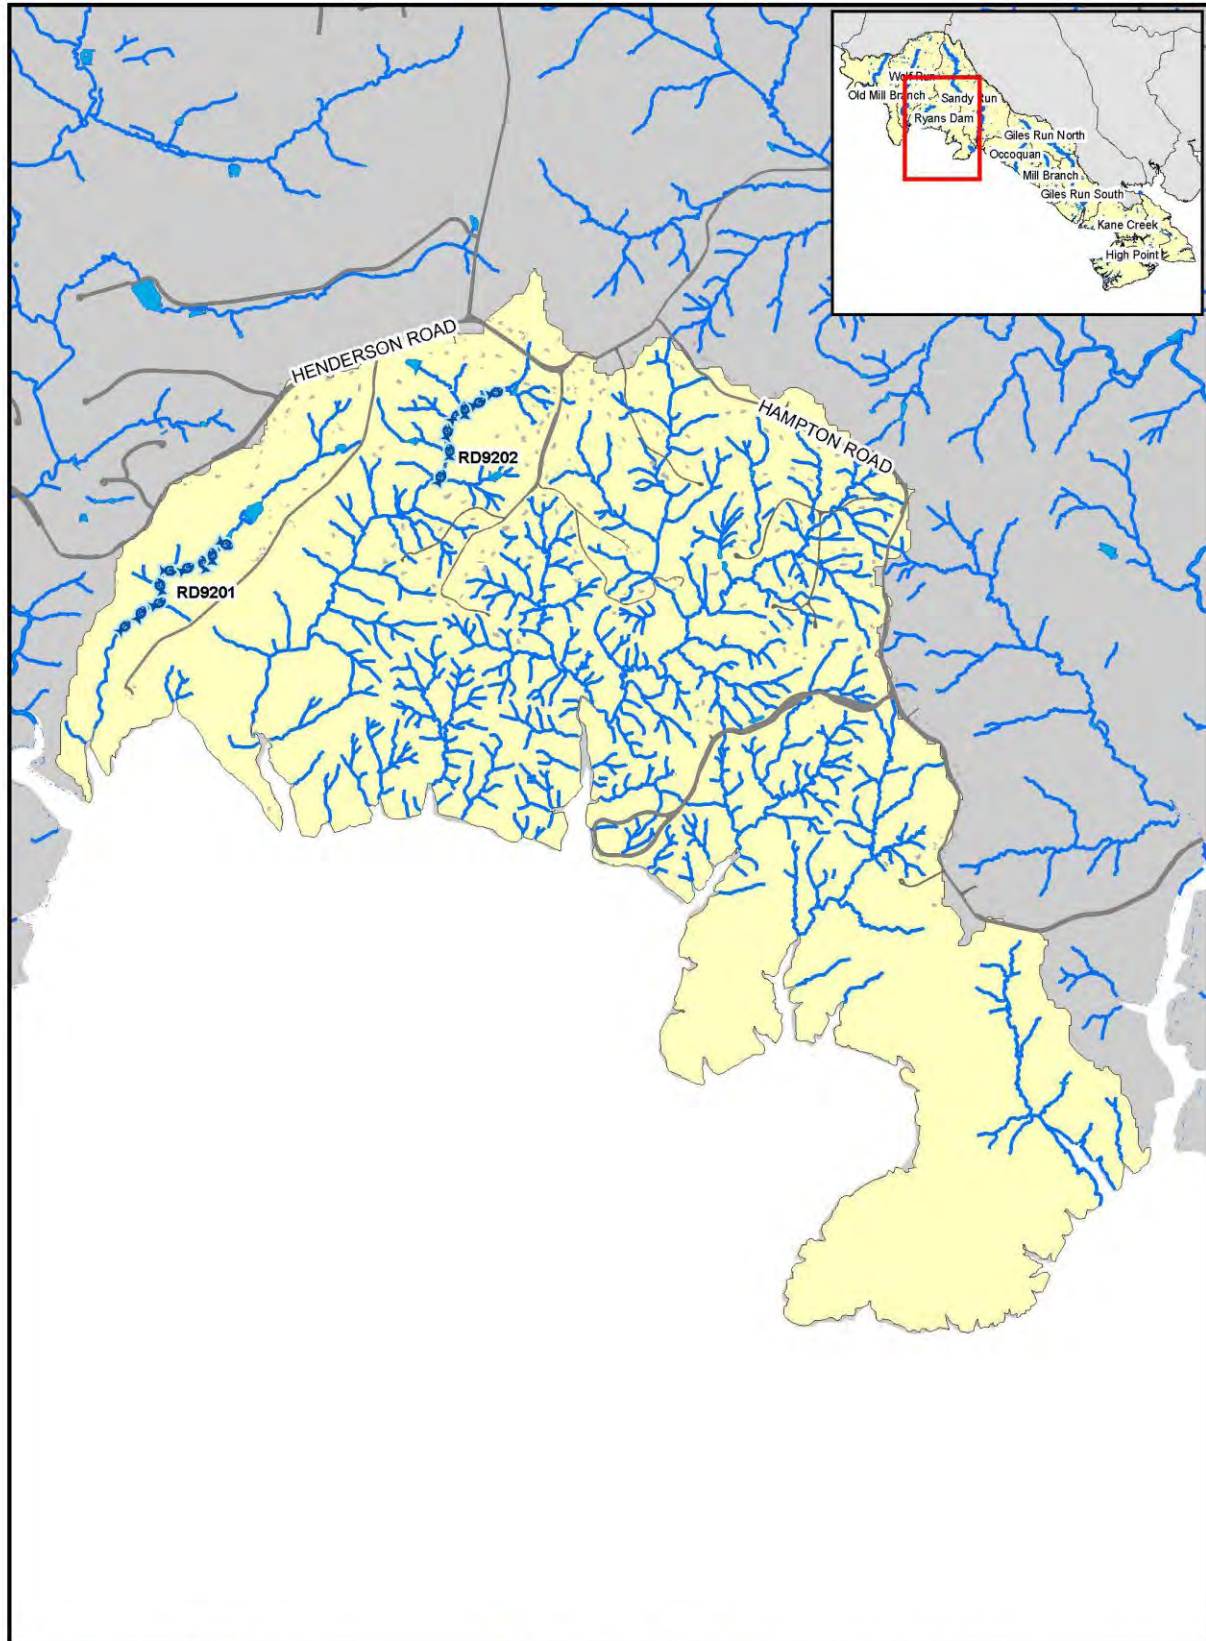
<p>0 0.125 0.25 Miles</p> <p>N</p>	<ul style="list-style-type: none"> <li>  Buffer Restoration</li> <li>  Stream Restoration</li> <li>  BMP/LID</li> <li>  Culvert Retrofit</li> <li>  Dumpsite/Obstruction Removal</li> </ul>	<ul style="list-style-type: none"> <li>  New Stormwater Pond</li> <li>  Outfall Improvement</li> <li>  Stormwater Pond Retrofit</li> <li>  Other</li> </ul>	<ul style="list-style-type: none"> <li>  Area-wide Drainage Improvement</li> <li>  Community Outreach/Public Education</li> <li>  Land Conservation Project</li> <li>  Flood Protection/Mitigation</li> <li>  Inspection/Enforcement Enhancement</li> <li>  Rain Barrel Program</li> <li>  Street Sweeping Program</li> <li> Studies, Surveys and Assessments</li> </ul>	<p><b>Map 5.8</b></p> <p>Ryans Dam WMA Proposed Projects</p>
--	---	---	---	--

Implementation timeframe denoted by project label color. Red = 0-10 years Black = 11-25 years.

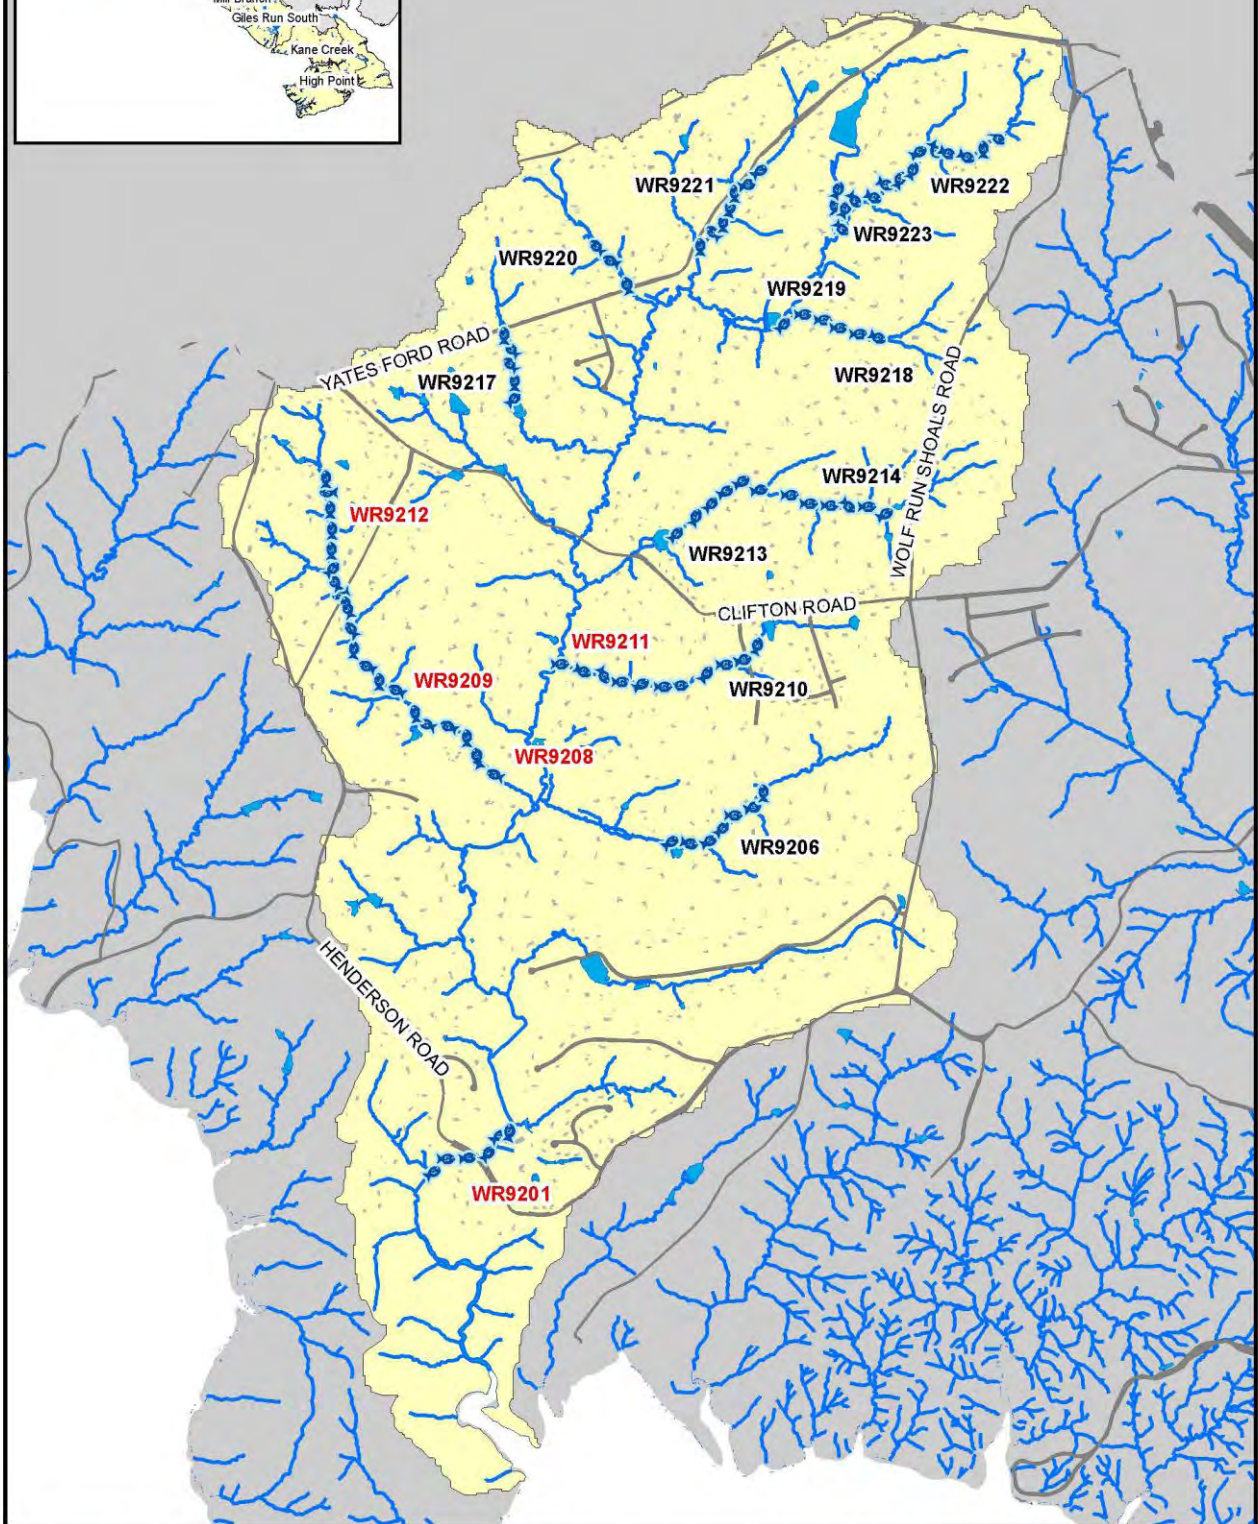
Buffer Restoration	New Stormwater Pond	Area-wide Drainage Improvement
Stream Restoration	Outfall Improvement	Community Outreach/Public Education
BMP/LID	Stormwater Pond Retrofit	Land Conservation Project
Culvert Retrofit	Other	Flood Protection/Mitigation
Dumpsite/Obstruction Removal		Inspection/Enforcement Enhancement
		Rain Barrel Program
		Street Sweeping Program
		Studies, Surveys and Assessments

Implementation timeframe denoted by project label color. Red = 0-10 years Black = 11-25 years.
