Accotink Creek Watershed Management Plan DRAFT

Watershed Workbook
October 2008

*Fairfax County Department of
Public Works and
Environmental Services*

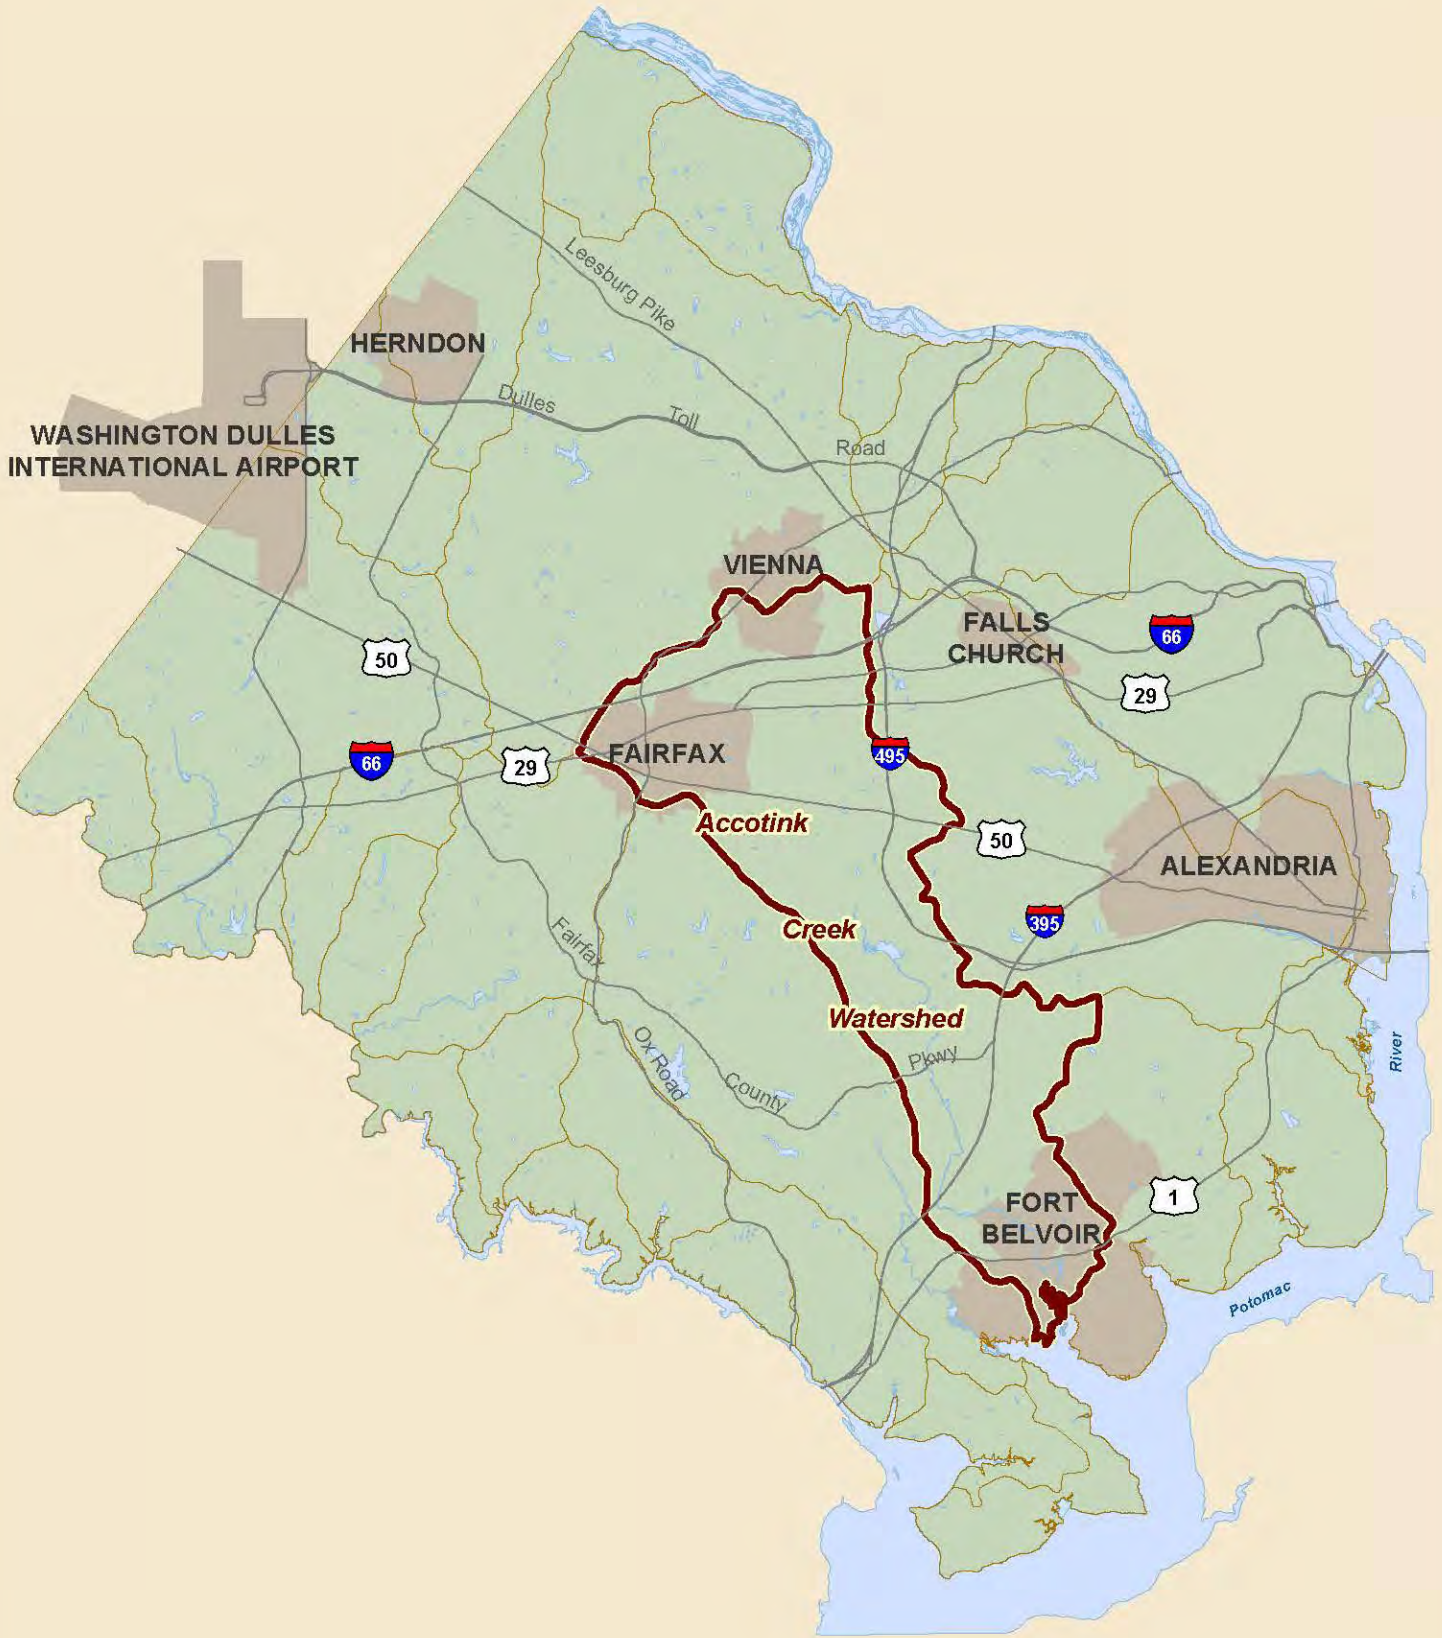
Map 1-1

Watershed Location Map

Accotink Creek Watershed
